HURRICANE KATE STORM SURGE DATA

Report 5

Coastal Engineering Research Center

August 1987

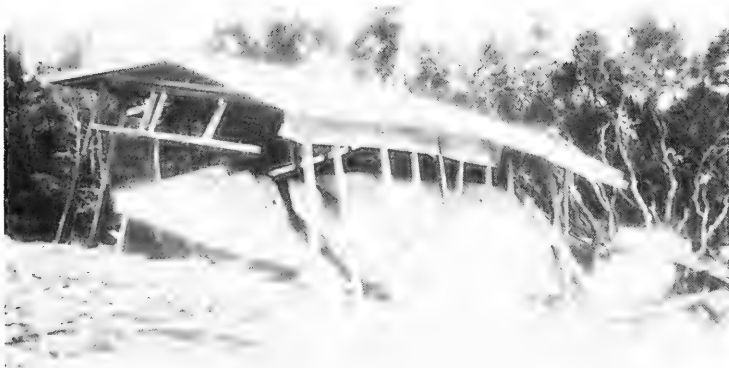
Photo 14. Trailer destruction between East Point and Carrabelle, Fla.
